East Budleigh Conservation Area

Appraisal Review and Management Plan

April 2020

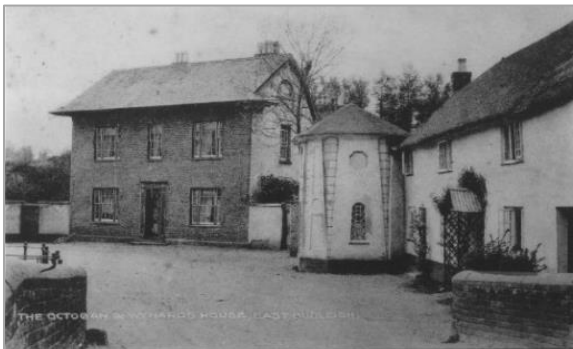
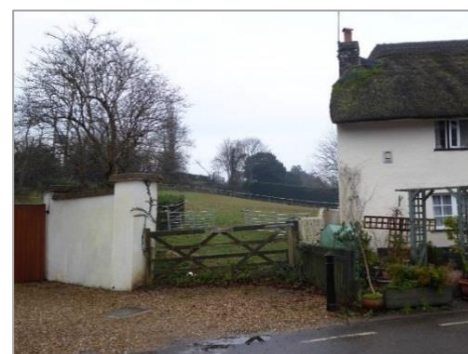
***Photos:
The former
Toll House
and view
beyond it
after
demolition***

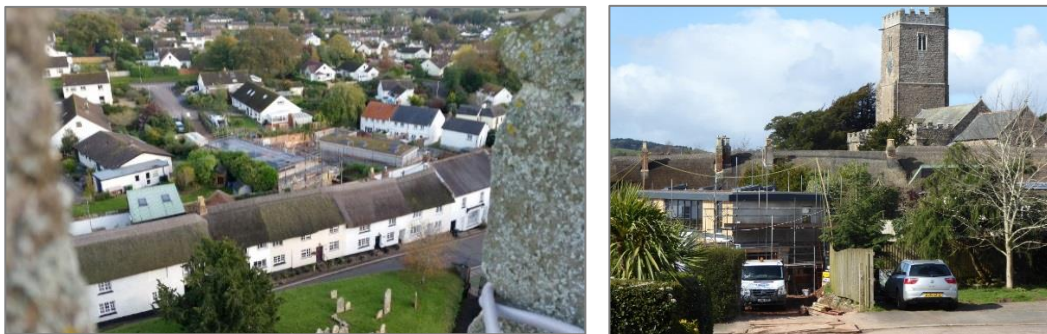
- 6.9 The High Street is so unspoilt that distractions, such as the power lines and yellow road markings, are even more apparent within this enclosed area. However, the road markings also have a positive impact as there are no unsightly parked cars to mar the streetscape.
- 6.10 Within the eastern border of the conservation area at Pynes Close, the setting has changed radically, from burgage plots to the 21st century housing under construction at the time of survey.

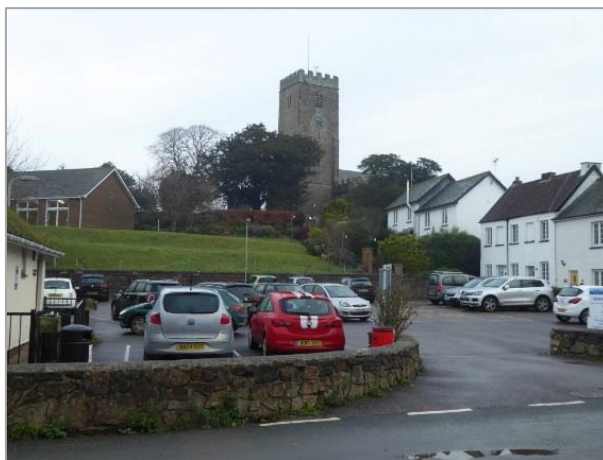
However from evidence in early photographs, the eastern part of Hayes Lane has been much compromised. As well as a sizeable car park with walls of poor quality enclosing it, some new housing and the Church Hall built in the late 1970's create a somewhat jarring note and too prominently assert their presence in the foreground of the church tower. The cobbles of Church Lane, an attractive and unusual feature, had been gravelled over for some years prior to the 2019 survey. **Photo: Hayes Lane, car park looking towards Church Lane**

Boundary walls: some unattractive concrete block walls around the car park on Hayes Lane, subject to available resources, could be improved with replacement or removal where practical, or facing with alternative materials and decoration. Other boundary walls can be enhanced by repair and maintenance with suitable materials.

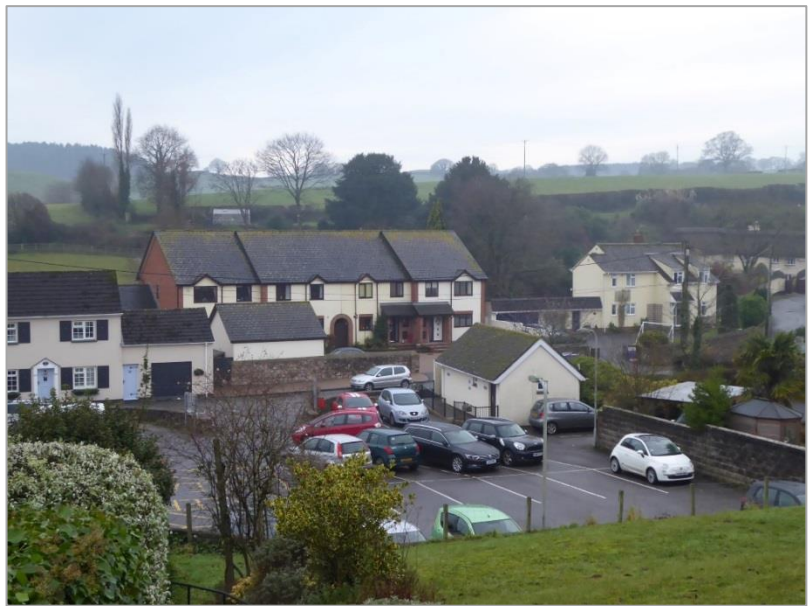
The new housing on Hayes Lane (late 1980's) and in All Saints' Close (late 1990's) is mostly terraced, with one larger detached house. Although walls are rendered, they do not follow the local style.

Photo (right): modern housing, car park and toilet block on Hayes Lane, looking south from the grounds of All Saints' church.

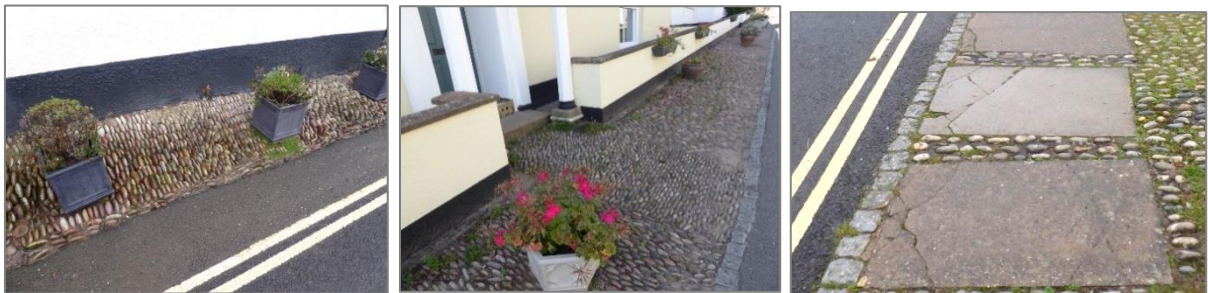
- 9.1 In the High Street there are some especially good areas of round cobbles, particularly on the west side, some forming decorative patterns. It is likely that these date from the time that classical detail was added (early 19th century). There is a similar extent on the east side, but this is narrower, less well maintained and some are covered over with tarmac in places. Nevertheless, overall this is a remarkable survival which needs to be carefully conserved.
- 9.2 Elsewhere in the village are several forecourt areas and accesses which have not been spoiled with resurfacing materials.

Photos: Examples of hard surfaces, showing how original cobbles and granite setts have maintained a better condition than the replacement concrete surface

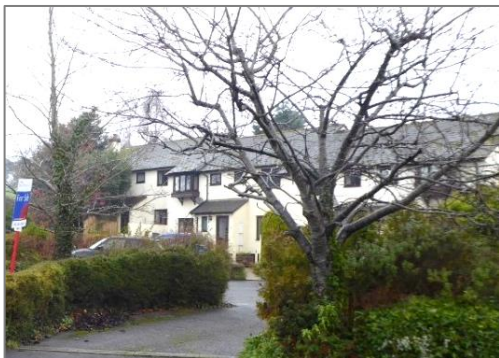
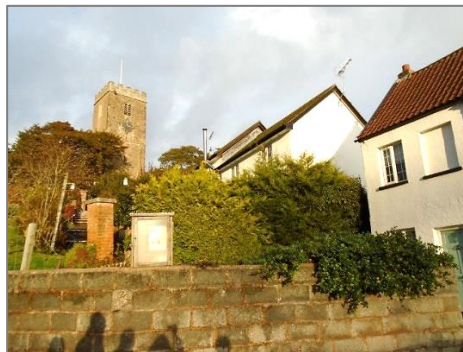
**Photos:
Modern
(1980's and
1990's)
housing off
Hayes Lane**

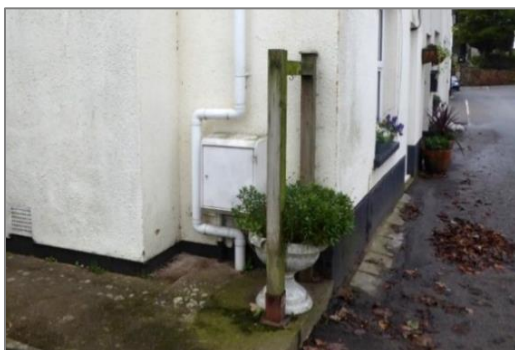
However there has been much loss of original detail and some replacement UPVC windows and doors, rainwater goods and the installation of wall mounted meter boxes, which contribute to the buildings' loss of character. These frontages are no longer considered to be largely unspoilt and Map 2 has been amended to reflect the 2019 survey.

- Detracting features on buildings include wall mounted meter boxes, UPVC windows, doors and rainwater goods, such as those seen at Vicarage Road.

**Photos: Examples of wall
mounted meter box and
UPVC windows and door,
illustrating loss of
character for some
cottage frontages on
Vicarage Road.**

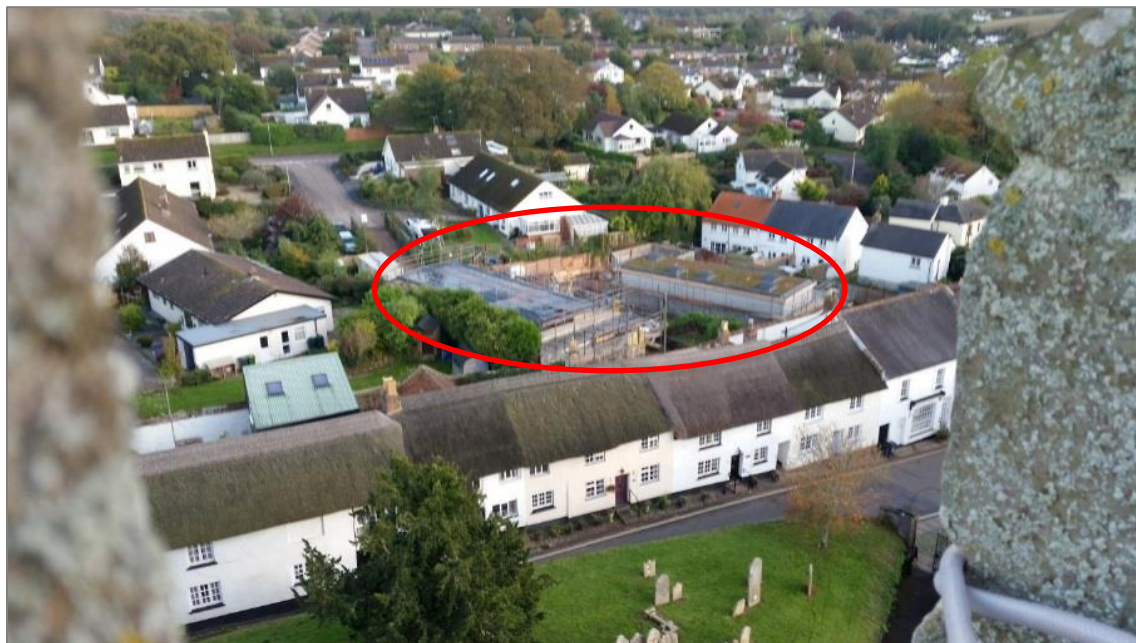
- 14.5 The design was considered to be fairly sensitive to the setting of the High Street roofline when viewed from Pynes Lane. “The introduction of two contemporary dwellings, with green roofs would result in some harm to the glimpsed views however the identified harm does not undermine the integrity of the Conservation Area”.

Photo: New development at Pynes Close within the conservation area, under construction at time of survey in 2019 (circled in red)
